My Henry Paulson Supreme 8mm Micrometer Watch Lathe

Copyright 2018 by James P. Riser

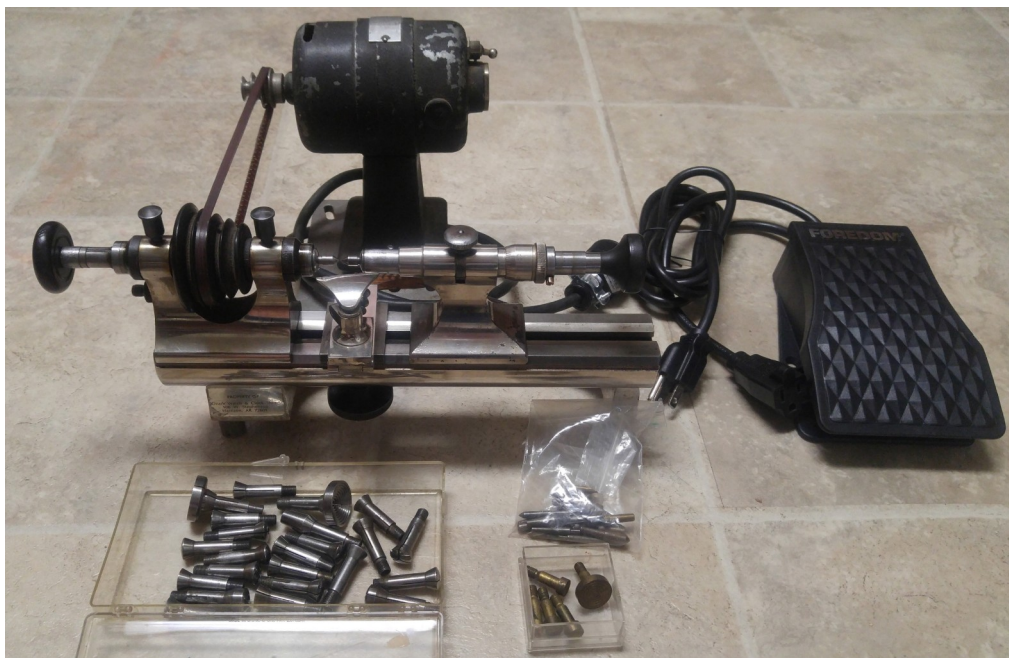
1. The Paulson lathe with tip over toolrest
2. A Vigor reversible motor
3. 22 assorted wire chucks (collets)
4. A wax chuck with assorted brasses
5. Two center collets
6. Assorted centers
7. New Freedom foot control

8. The Borel base

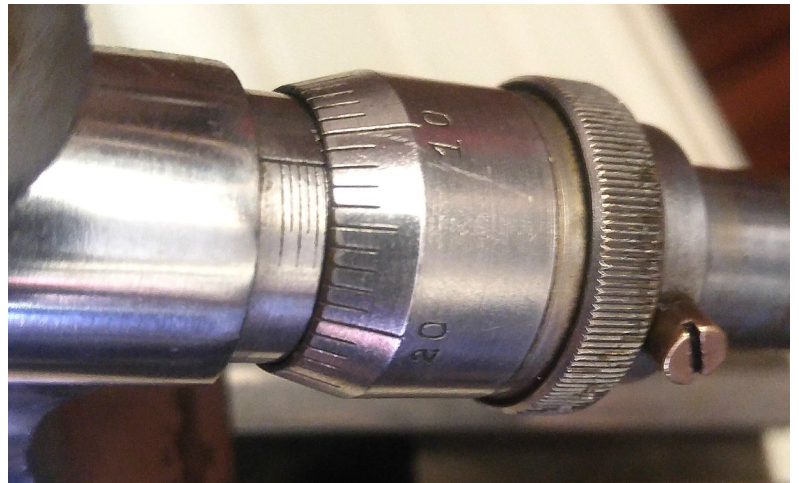
Here is a close up view of the micrometer tailstock adjustment for depth control.
